## CERTIFICATE of QUALITY TEST

Test report - No. 8997.02 / 12

Client	<b>Siemens AG</b> <b>IC SG EA PRO D 6 2</b> Wernerwerkdamm 5 13629 Berlin	
Equipment under test	<b>Protection Relay 7SJ80</b> MLFB 1 specimen	$\frac{1}{3}$ of 19" for panel flush mounting 7SJ8031-5EB90-1FB0/CC L0R BF1111049068
Purpose	<b>Environmental test of the corrosive resistance</b> This test is capable of verifying the usability of electronics in G3 environments according to the ANSI/ISA-71.04-1985 environmental conditions for process and measurement and control systems: airborne contaminants.	
Test program	<b>Corrosive gas 4 components</b> according to IEC 68-2-60 and according to the demands of the client	
Test duration	21 days and 7 days and 6 days	
Test period	13 January to 16 February 2012	
Pictures	see appendix 1	
Realization	see test Report No 1888-0131211 _2_ Rev 2, Test Lab Beck-Messtechnik / 28.03.2012 in appendix 2	
Test result	<b>After the corrosive test no neither corrosion phenomena nor deposits were detected at the specimen.</b> <b>An visual evaluation was done after 504 h, after 672 h and after 816 h.</b> <b>The further evaluation will be done by the client.</b>

## 1888-0131211\_2\_Rev2

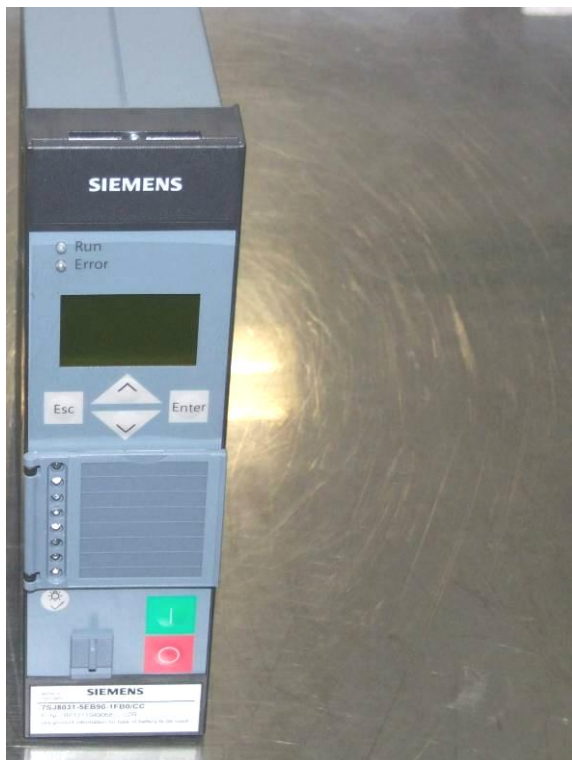
**picture 1**  
**Protection Relay 7SJ80**  
*before the corrosive test Ke*

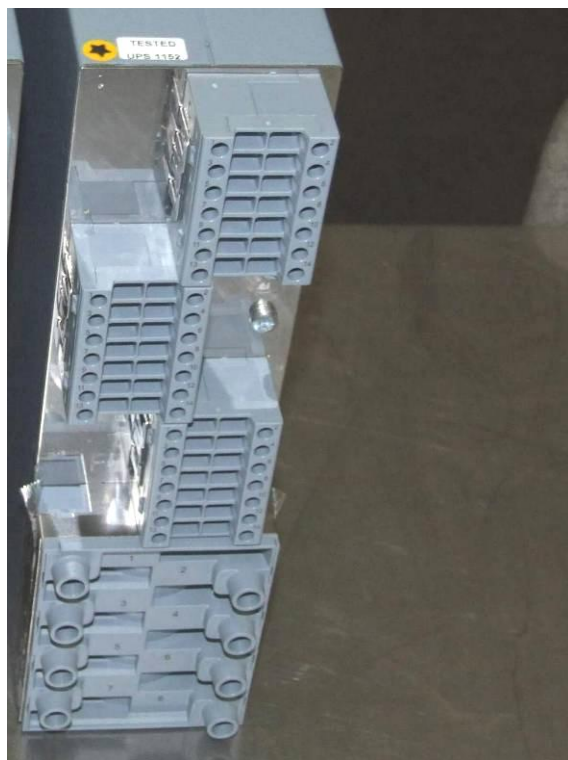
**picture 2**  
**Protection Relay 7SJ80**  
*before the corrosive test Ke*

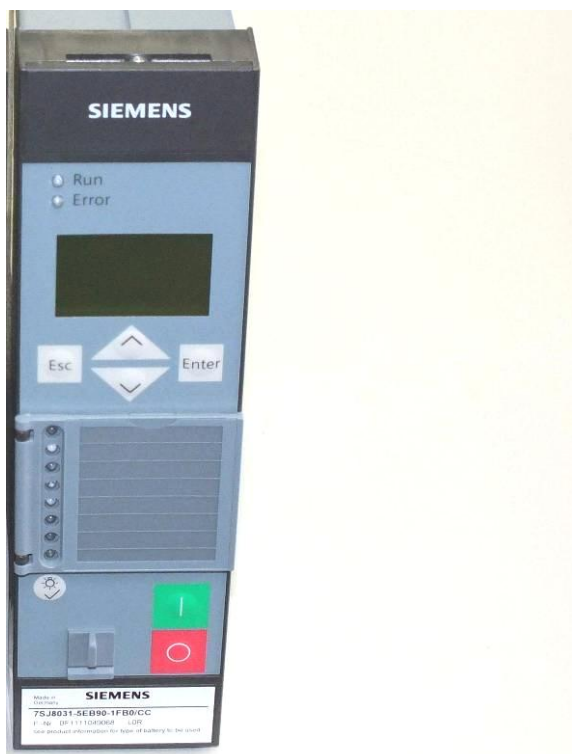
**picture 3**  
**Protection Relay 7SJ80**  
*without visible corrosion phenomena or deposits*  
*after the corrosive test Ke*

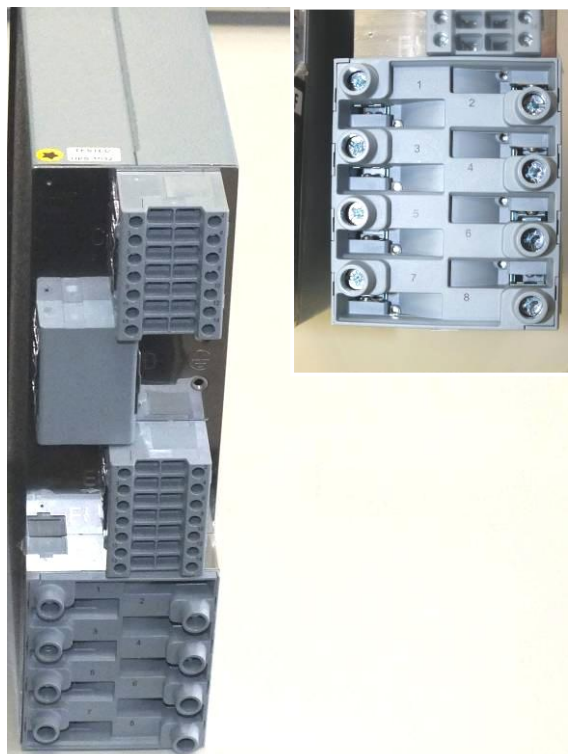
**picture 4**  
**Protection Relay 7SJ80**  
*without visible corrosion phenomena or deposits*  
*after the corrosive test Ke*

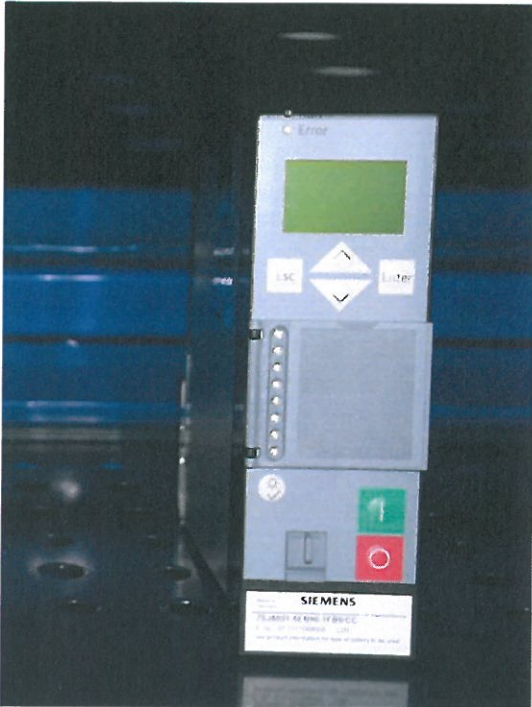
Picture 1: Installation of the test samples at the start of the test

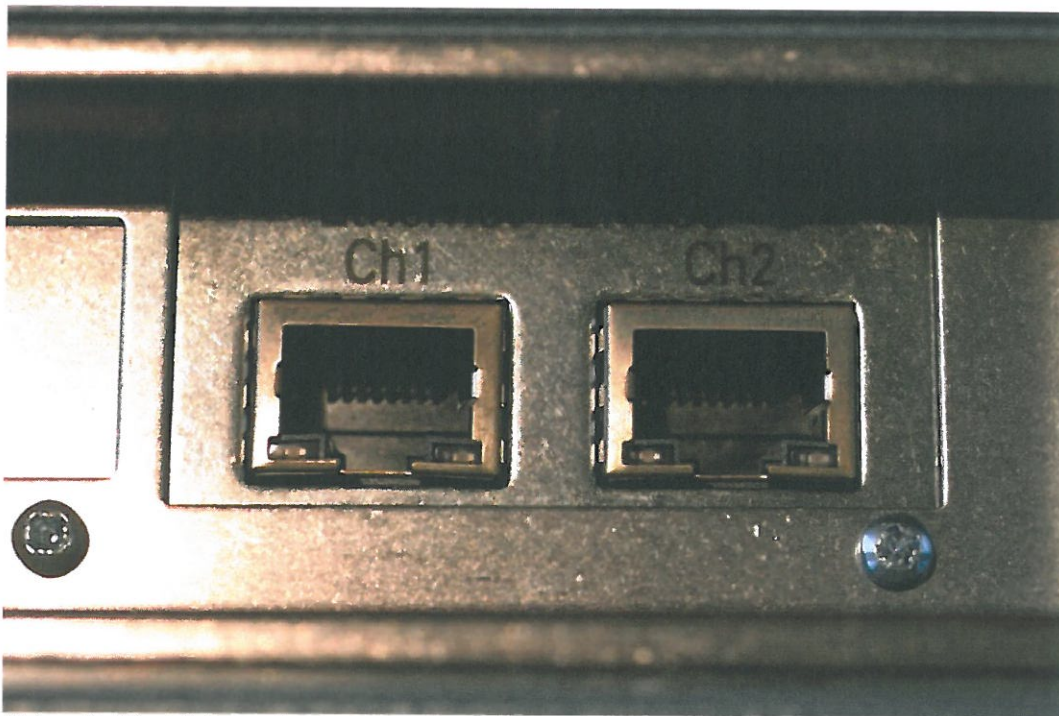
Picture 2: After 504h run-time

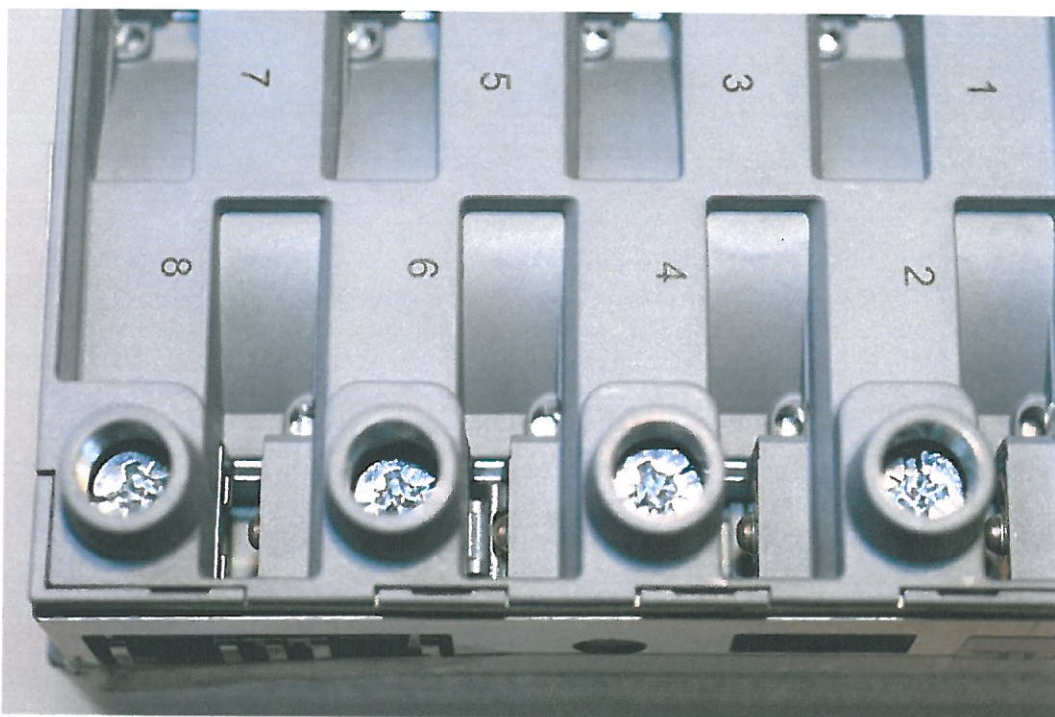
Picture 3: After 504h run-time

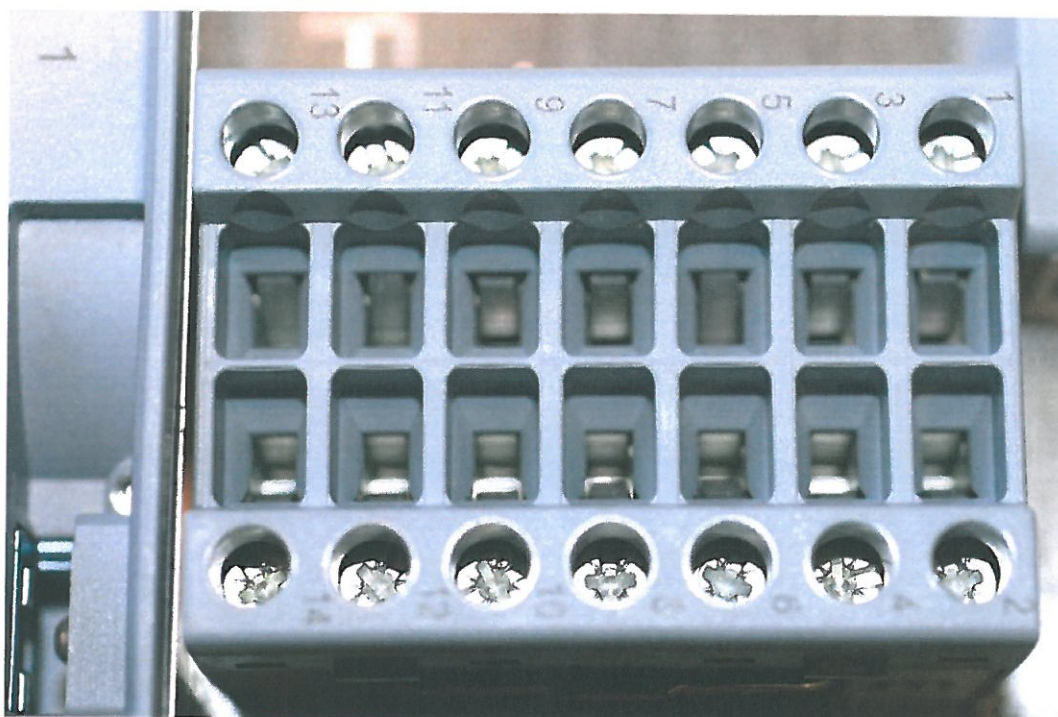
Picture 4: After 504h run-time

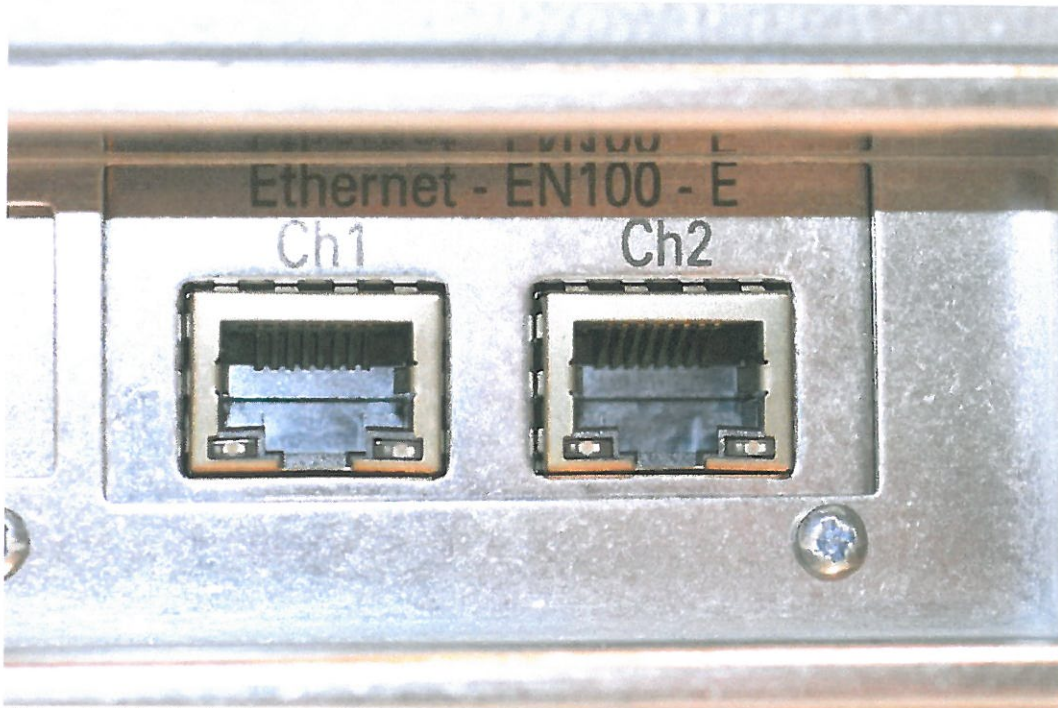
Picture 5: After the test

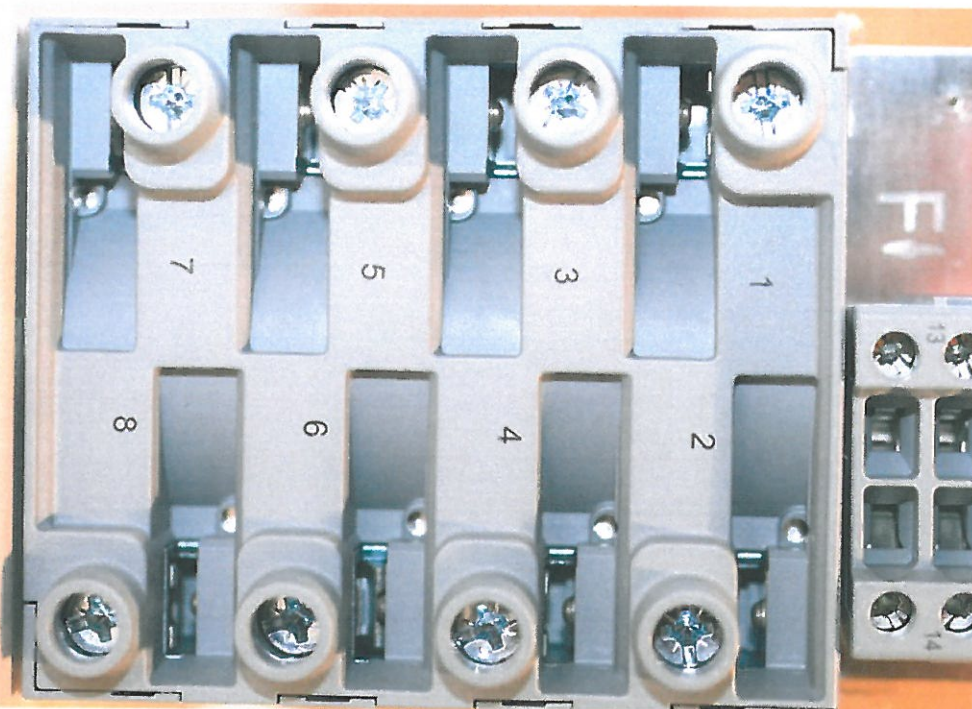
Picture 6: After the test

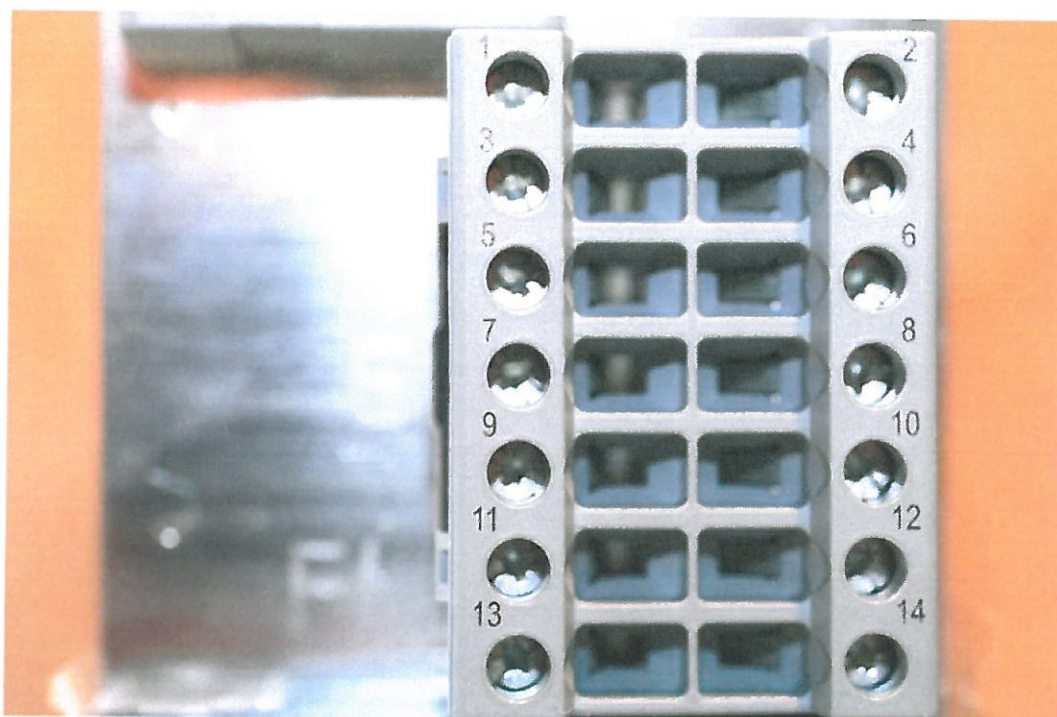
Picture 7: After the test
