CERTIFICATE of QUALITY TEST

Test report - No. 8997.06 / 12

Equipment under test Protection Relay 7SK80

Purpose Environmental test of the corrosive resistance

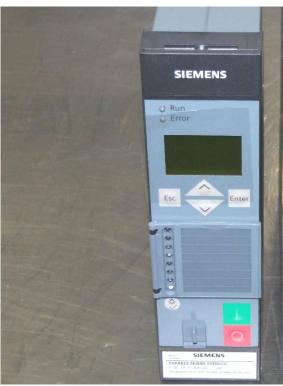
picture 1 Protection Relay 7SK80 before the corrosive test Ke

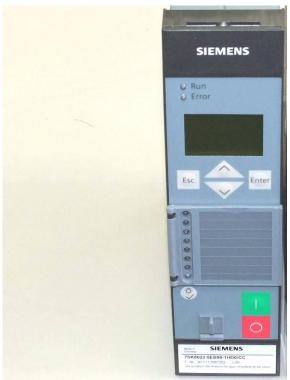
Test result After the corrosive test no neither corrosion phenomena

nor deposits were detected at the specimen.

picture 3 **Protection Relay 7SK80** without visible corrosion phenomena or deposits without visible corrosion phenomena or deposits after the corrosive test Ke

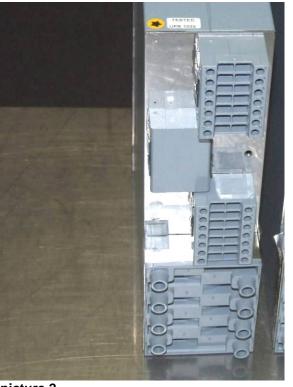
picture 2 **Protection Relay 7SK80** before the corrosive test Ke

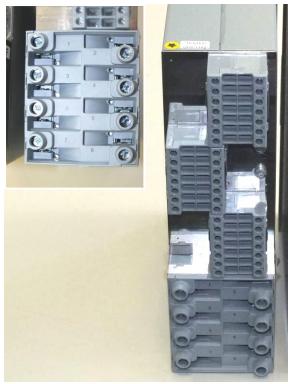
picture 4 **Protection Relay 7SK80** after the corrosive test Ke

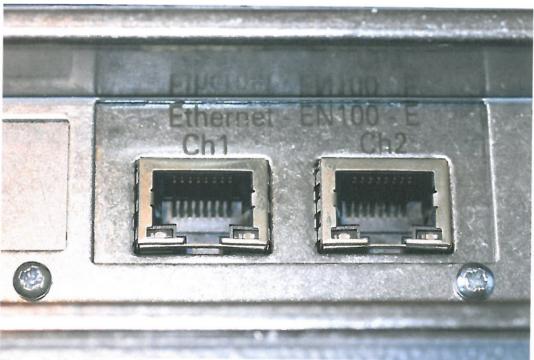
Picture 1: Installation of the test samples at the start of the test

At the beginning of the test, the test object had no optical abnormality.

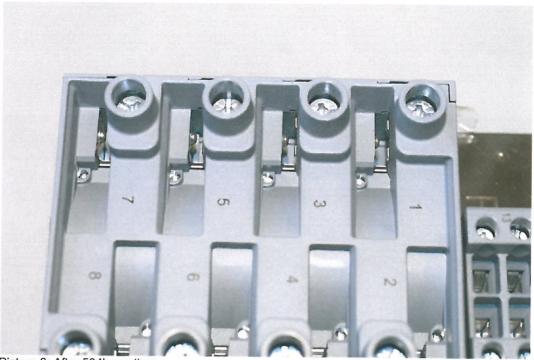
Picture 2: After 504h run-time

At the interim evaluations (504h and 672h) no optical abnormalities were detected. At the end (after 816h) also no optical abnormalities or

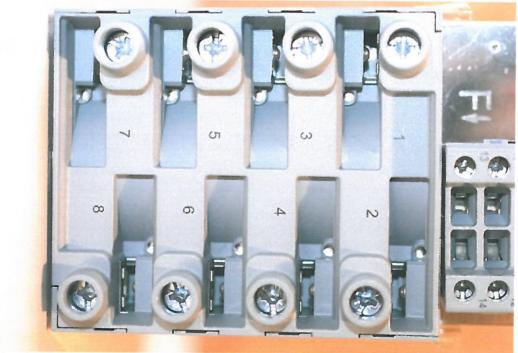
Picture 5: After the test

any damages were detected.
