Corrosive sulfur in transformer oil

Technical bulletin on problems,
consequences and recommendations for treatment

Power Transmission and Distribution

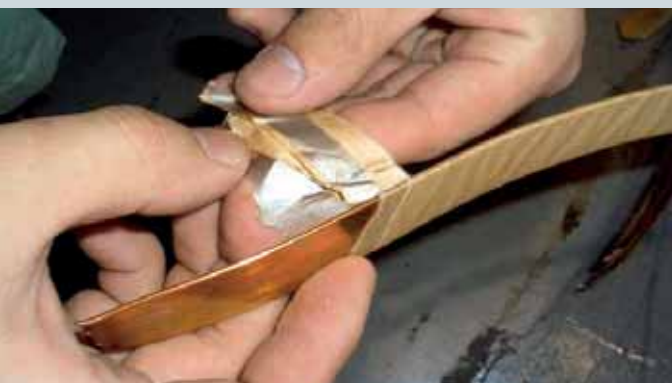
Fig. 2: Dewatering of a paper insulated conductor showing deposits of copper sulfide on the paper insulation

In most cases copper sulfide deposits can not be detected by a simple inspection. The copper wire needs to be de-wrapped and the paper to be degreased in order to make visible the shiny deposits (Fig. 2). In some cases the copper conductor can be dark or multi-colored. The discoloration can significantly vary within the length of the same conductor.

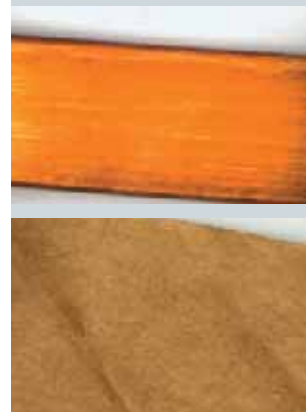
Fig. 3a: Copper and paper strips after a test with not corrosive oil

Fig. 3b: Copper and paper strips after a test with corrosive oil

The testing method proposed by Siemens has been evaluated in a Round Robin Test within CIGRE TF A2.32.01 and has been proposed for standardization. This test adopts a paper-wrapped copper conductor and transformer oil at 150°C for 72 h. Both the copper conductor and the paper strip are evaluated for discoloration and deposition (Fig. 3a and Fig. 3b).
